Site Image And Address

Aims Electrical
Ph: 09) 274 8812
Fax: 09) 274 8819
Email: aims.electrical@xtra.co.nz

Summary of inspection for:

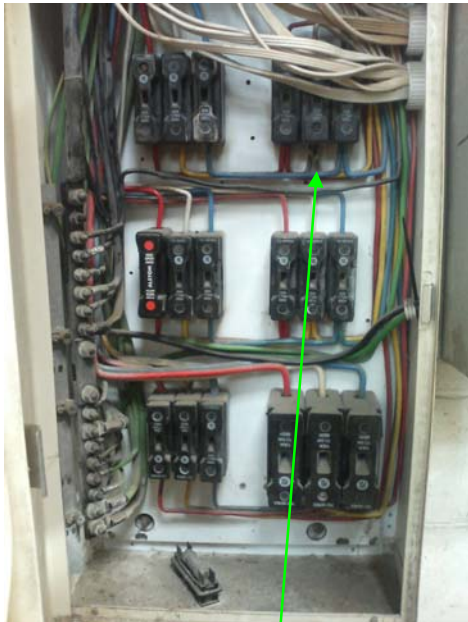
The surveyed equipment is Distribution board 3, which is located on the wall as you enter into the Factory.

This Board was under normal load conditions when the survey was done.

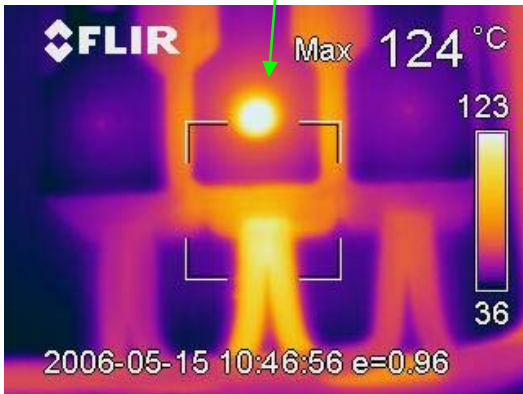
IR information	Value
Emissivity	.96
IR: max	124°C
IR: min	36°C
Measured amps	32 A
Rated amps	63 A
Calculated max temp	58.2°C
Area temp	124°C
Date	26/05/2006
Priority	D

As the thermal image shows this connection into the supply side of the fuse holder appears to be loose, the measured temperature greatly exceeds the calculated maximum temperature, Corrective measures required ASAP.

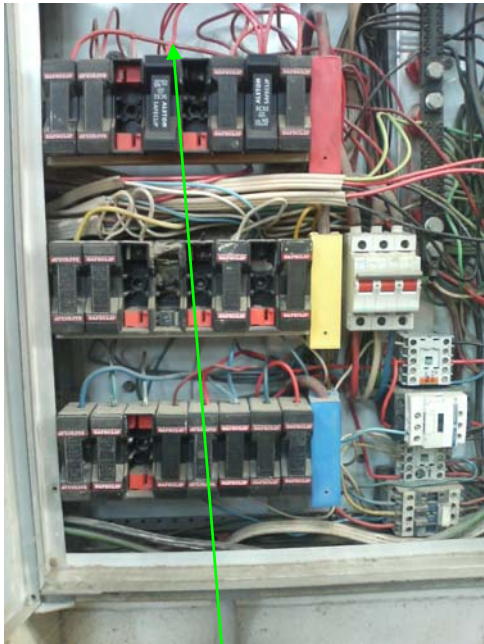
Inspected equipment: DB 3A

The surveyed equipment is Distribution Board 3A, which is located on the wall as you enter into the Factory

The Board was under normal load conditions when the survey took place.

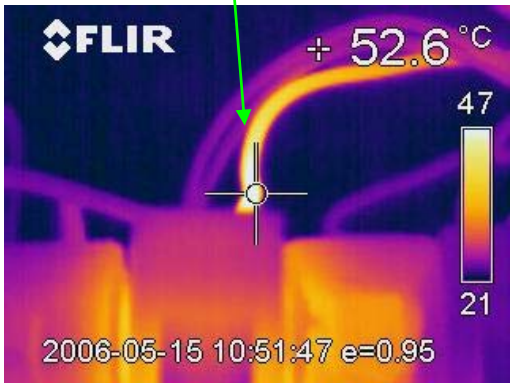
IR information	Value
Emissivity	.95
IR: max	52.6°C
IR: min	21°C
Measured amps	11 A
Rated amps	20 A
Calculated max temp	33.47°C
Spot temp	52.6°C
Date	26/05/2006
Priority	C

As the thermal image shows the wires measured temperature exceeds the calculated maximum running temperature, Corrective measures are required as scheduling permits.

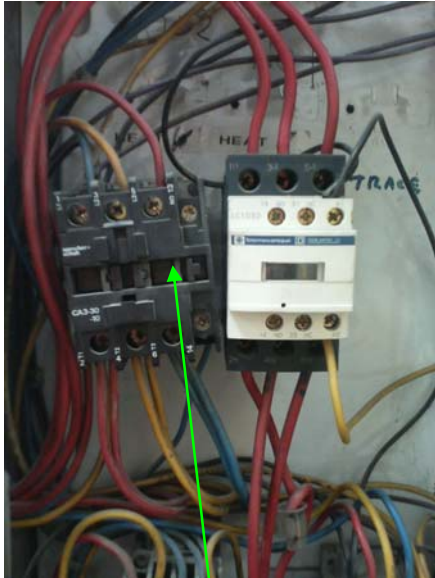
The surveyed equipment is Distribution Board 7, which is located between #1 and #2 bitumen machines in the Factory.

The Board was under normal load conditions when the survey took place.

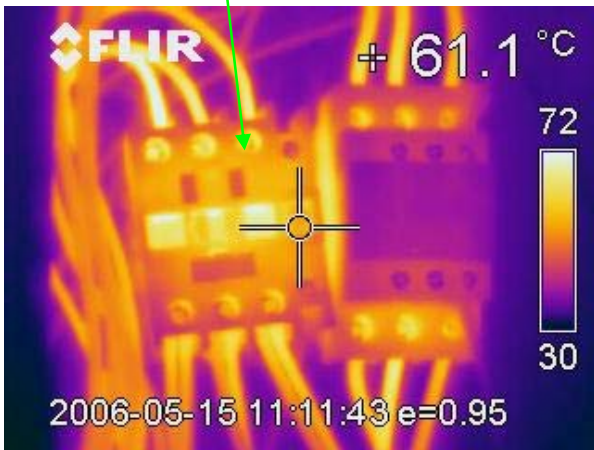
IR information	Value
Emissivity	.95
IR: max	72°C
IR: min	30°C
Measured amps	27.5 A
Rated amps	32 A
Calculated max temp	44.4°C
Spot temp	61.1°C
Date	26/05/2006
Priority	B

As the thermal image shows the contactor exceeds its maximum rated temperature, Corrective measures required as scheduling permits.

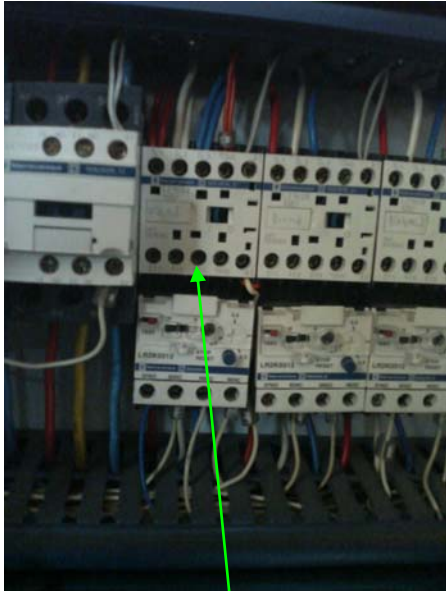
Inspected equipment: DB 8

The surveyed equipment is Distribution Board 8, which is located on the Eastern wall of the Factory.

The Board was under normal load conditions when the survey took place.

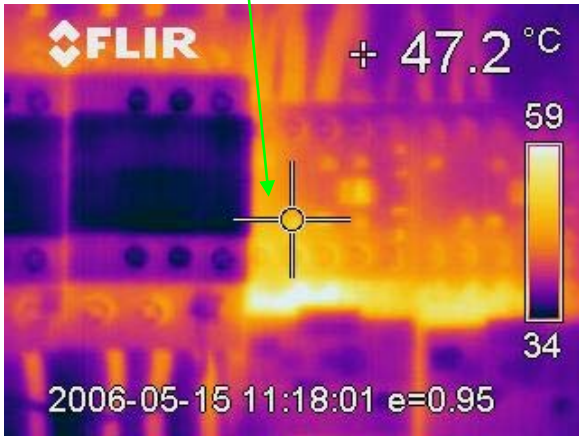
IR information	Value
Emissivity	.95
IR: max	59°C
IR: min	34°C
Measured amps	3.3 A
Rated amps	20 A
Calculated max temp	35.4°C
Spot temp	47.2°C
Date	26/05/2006
Priority	B

As the thermal image shows the contactor exceeds normal calculated temperature rise, Corrective measures required as scheduling permits.

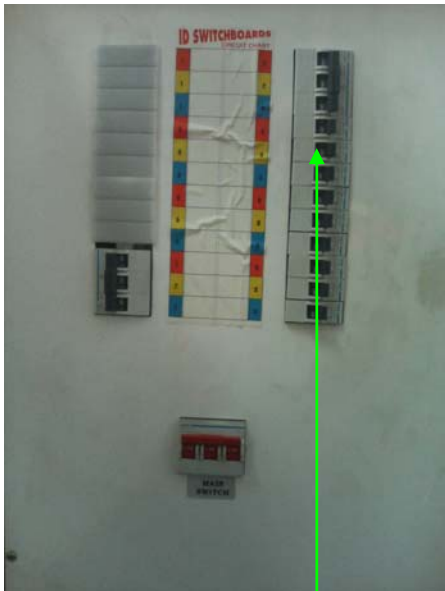
The surveyed equipment is Distribution Board 10, Factory.

The Board was under normal load conditions when the survey took place.

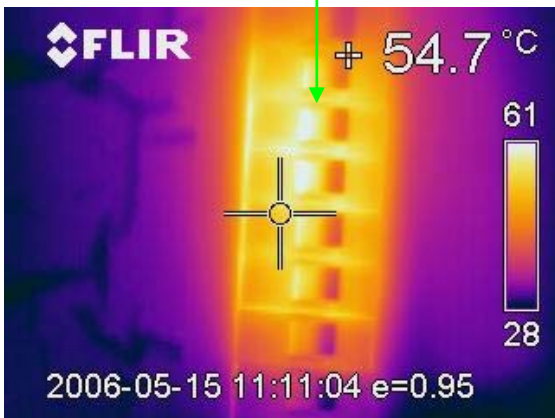
IR information	Value
Emissivity	.95
IR: max	61°C
IR: min	28°C
Measured amps	29 A
Rated amps	32 A
Calculated max temp	49.92°C
Spot temp	54.7°C
Date	26/05/2006
Priority	A

As the thermal image shows the breakers exceed the calculated maximum temperature, Corrective measures should be taken at the next maintenance period.
